City of Baltimore Wet Smoke and Dyed	Page 1 of 2	
Sewershed: Gwynns Falls	Company: Savin	Date: 9/8/2009
Test to be performed: Smoke Dyed Water X		Supervisor: JAW
Manhole_ID: S04CC1017MH	Test ID: <u>D1032-027014</u>	Notification Made: NA (Residents, Fire, 311)

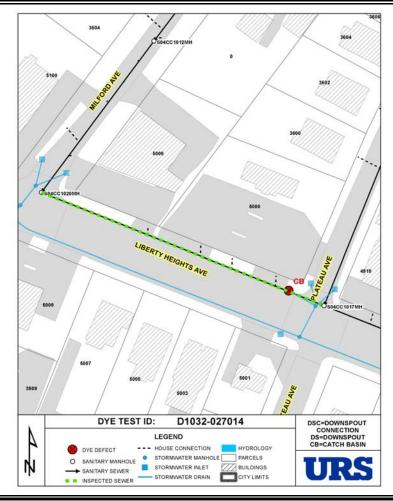
Field Sketch: Show all manholes with Numbers, Blower Placement Locations, Sandbag or Isolation Locations, Street Names, Building Addresses and Locations, Defect Locations and Photo Numbers.

Defect Loc	Obs_ClockFrom	Obs_ClockTo	Observation	Obs_Remarks
0			Start of Survey	
0			Manhole	S04CC1017MH
7			Dye Test Visible	DYE SEEN AT JOINT
10			Dye Test Visible	DYE SEEN AT JOINT
12.89999962			Dye Test Visible	DYE SEEN AT JOINT
15.5			Dye Test Visible	DTE SEEN AT JOINT
19.29999924			Dye Test Visible	DYE SEEN AT JOINT
22.10000038			Dye Test Visible	DYE SEEN AT JOINT
25.29999924			Dye Test Visible	DYE SEEN AT JOINT
28.20000076			Dye Test Visible	DYE SEEN AT JOINT
31.10000038			Dye Test Visible	DTE SEEN AT JOINT
